Manhole Inspection Summary

Manhole # S25A__017MH

Insp Date: **7/24/08 3:21 PM**

Location Address: **1211 HARLEM AVE**

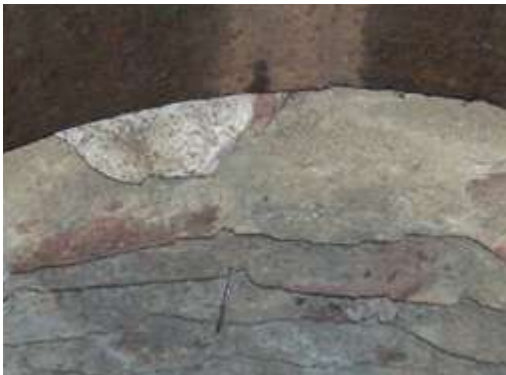
Defect 3

Condition: ☐ Sound ☐ Cracked ☐ Root Intrusion ☐ Loose Brick ☒ **Deteriorated**

CORBEL DETERIORATION

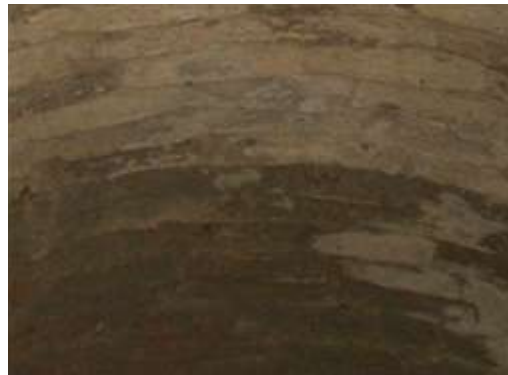
Defect 2

Infiltration: ☐ None ☐ Joint ☐ Cracks ☐ Mortar ☐ Roots ☒ **Wall**

BARREL INFILTRATION

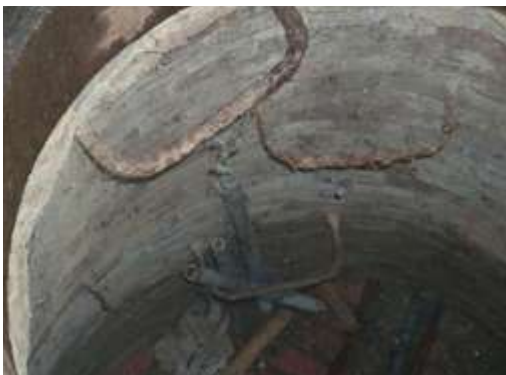
Defect 1

Count: **3** Missing: **1** ☒ **Corroded**

MISSING AND CORRODED STEPS

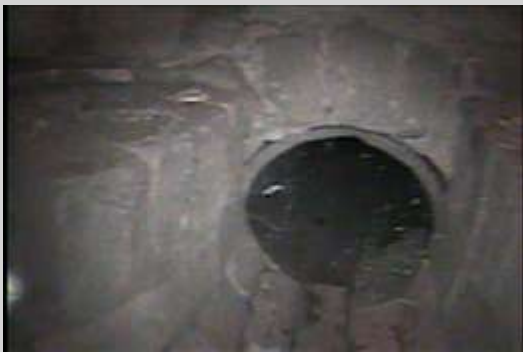
12 O'Clock Outflow

Pipe Height: **8.4** (in.) Rod and Bar (Angled)
Pipe Material: **Clay** ☐ Pipe Lined
Invert Depth: **8.33** (ft.) Flow Characteristics: **Slow**
Deposits: ☐ None ☐ Mud ☐ Sludge ☒ **Debris** ☐ Grease
Silt Depth: **1** (in.) Deposits Extent: **Light**
Infiltration: **None** Pipe Seal Cond: **Cracked**

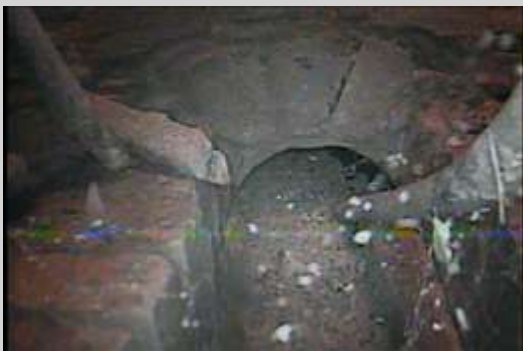
4 O'Clock Inflow

Pipe Height: **6** (in.) Rod and Bar (Angled)
Pipe Material: **Clay** ☐ Pipe Lined
Invert Depth: **7.87** (ft.) Flow Characteristics: **None**
Deposits: ☐ None ☐ Mud ☐ Sludge ☒ **Debris** ☐ Grease
Silt Depth: **5** (in.) Deposits Extent: **Heavy**
Infiltration: **None** Pipe Seal Cond: **Sound**

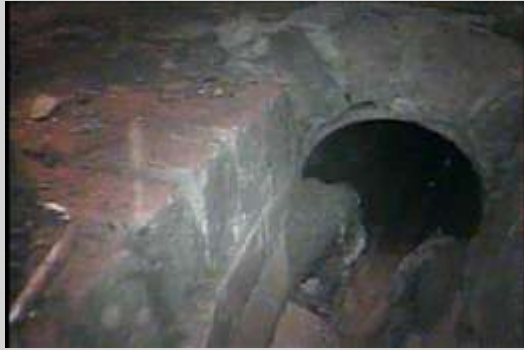
9 O'Clock Inflow

Deposits: ☐ None ☐ Mud ☐ Sludge ☒ **Debris** ☐ Grease

Silt Depth: **3** (in.) Deposits Extent: **Medium**
